Access Audit

**Our Lady Immaculate Catholic Primary School
Northumberland Terrace, Everton, Liverpool
L5 3QF**

Overview Report

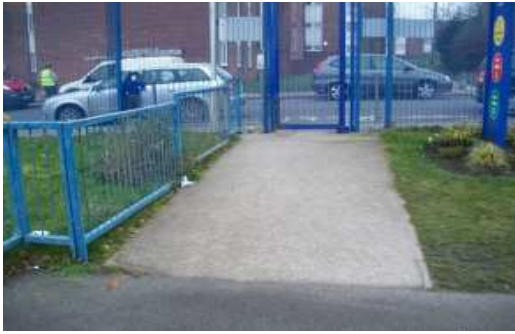
| Section/Question Ref | Section/Sub Section/Location/Question Description | Answer | Achievable | Comments |
|---|--|---|---|--|
| 1.4.1.8 | Are clear level landings provided at the head and base of the slope 1.5x1.2m, clear of any door/ gate swing or other protrusion? | No | Yes | The top landing is poor being uneven and the main gate protrudes onto this making it difficult for any wheelchair user to negotiate. As this is the main entrance for parents it is to be assumed that wheelchair users would use this access point. There is also no bottom landing as the ramp terminates onto the sloping playground. |

Access Ramp to Site

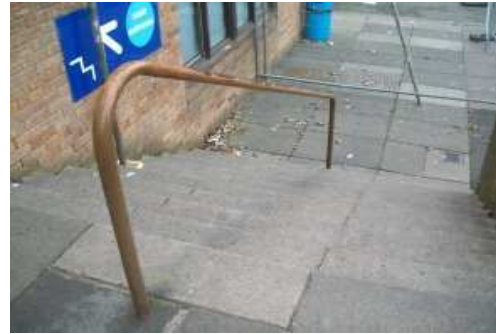
External Stairs (Limited Handrail Provisions)

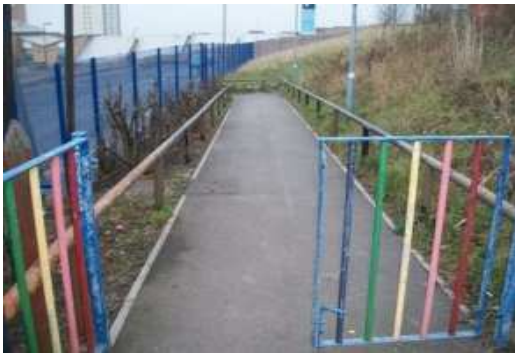
| Section/Question Ref | Section/Sub Section/Location/Question Description | Answer | Achievable | Comments |
|---|--|---|---|--|
| 1.4.2.5 | If the total rise of the ramp is in excess of 2m is an alternative mechanical means of access provided? | No | No | Due to the relief of the site, the rise from the main road to the nursery entry area is excessive with the existing gradient too steep for wheelchair users. Due to the entry point from the main road (Dukes Road) the gradient cannot be altered. The existing ramp is currently used for parents with prams and push chairs who are able bodied. This ramp should not be considered for anyone who is in a wheelchair or have walking difficulties. Some form of external access lift platform should be provided from the higher playground to the lower playground area to facilitate access to the nursery area for any wheelchair user. |

Rear Access Ramp

| Question Reference/Location | Description | Year | Comments |
|---|--|---|---|
| 1.4.2.1 | Provide an external wheelchair platform lift from higher playground to lower playground area | 2014 | The route will be from Northumberland terrace to the higher playground area with the lift providing access to the lower playground area where access to the nursery is available for wheelchair users. The adjacent steps can provide access for ambulant persons with walking difficulties (following minor alterations noted in the external stair section) |

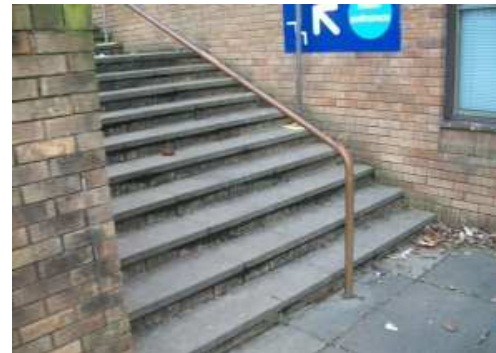
| Section/Question Ref | Section/Sub Section/Location/Question Description | Answer | Achievable | Comments |
|---|---|---|---|--|
| 1.5.1.5 | Are nosings highlighted using a strip of colour contrasting material, 55mm width to both the tread and riser? | Yes | | Paint markings worn |

No Markings to External Stairs

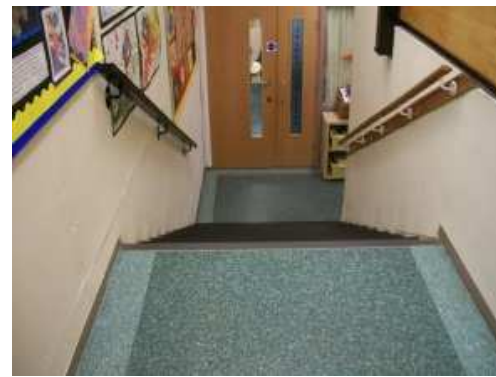
| Section/Question Ref | Section/Sub Section/Location/Question Description | Answer | Achievable | Comments |
|---|--|---|---|--|
| 4.5.1.20 | Is there a clearance of 60-75mm between the handrail and adjacent wall surface? | Yes | | RHS rail to lower flight sited too close to wall and noted for replacement in earlier question. |

Poor Handrail to Internal stair Leading to Nursery

| Question Reference/Location | Description | Year | Comments |
|---|--|---|---|
| 4.5.1.2 | Ensure that handrails to lower flight are between 900mm-1000mm from landing surfaces. Replace plastic RHS rail to lower flight as this is sited too close to wall surface. | 2014 | |

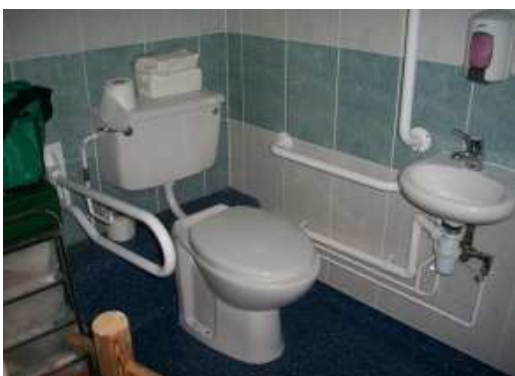
Main Accessible WC

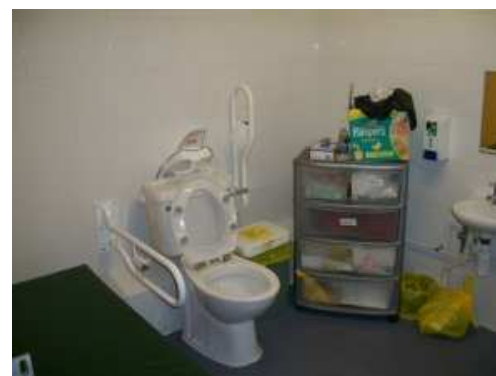
Nursery Accessible WC
